Picus Sonic Tomograph Testing

3 Kalgoa Road
Bellevue Hill NSW 2023

Prepared for
Woollahra Council

Prepared by
Paul Vezgoff
Consulting Arborist
Moore Trees
October 2008

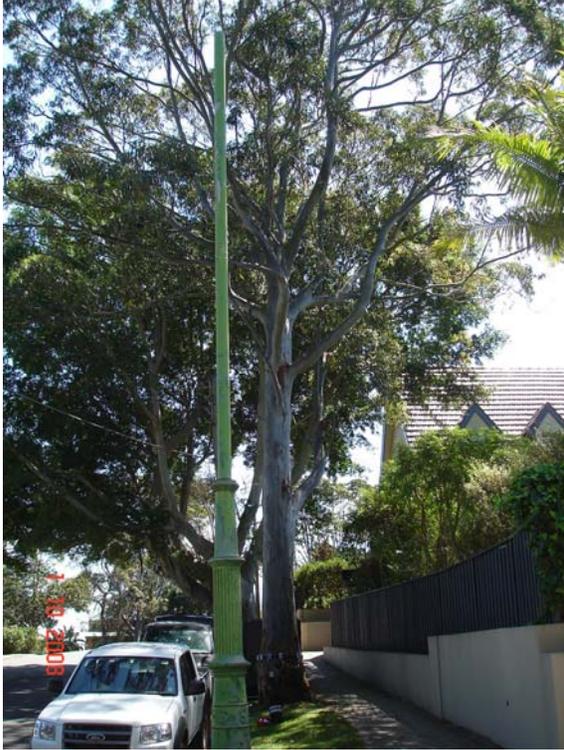
PICUS test conducted by: Paul Vezgoff
Test Height at sensor 1: 600mm
Tree Circumference: 3070mm
Botanical Name: Sydney Blue Gum
(*Eucalyptus saligna*)
Location: 3 Kalgoa Road Bellevue Hill
Date of test: 1/10/08

Plate 1: The subject tree. Image shows the tree has a symmetrical shape. Targets below the tree include, footpath, private and public property. P. Vezgoff.

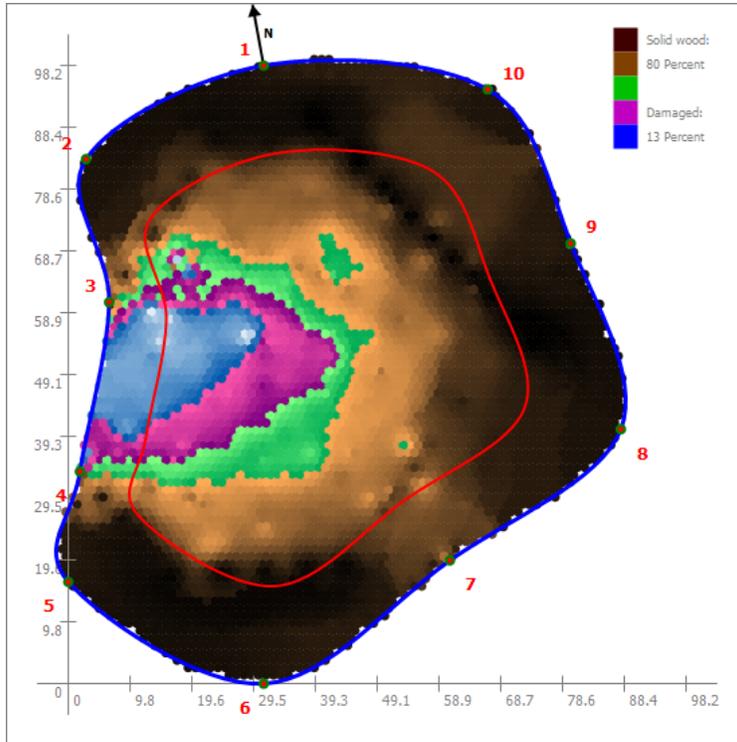
The Picus® Sonic Tomograph test was conducted at six hundred (600) millimetres from the base of the subject tree. This area was chosen as it was the most likely area of the greatest portion of decay to be present, due to a large wound on the western side of the tree. There appeared to be the possibility of decay fungi having entered the heartwood of the subject tree. The subject tree appeared to have a species of decay causing fungi that has caused the wood within the wound area to become soft.

The Tomogram shows that a decay fungus was found at the test location, in very small quantities. Test results indicate that there is approximately 80% sound wood at the test location (Plate 2).

Plate 2: Tomogram of the test site. Red line is indicative of the 70/30 linear measurement. P. Vezgoff.

The test revealed varying stages of decay at the test site with 80% sound wood at the test location. The tree is structurally sound at the test site and should be retained. A further test in twelve (12) months time should be conducted to ascertain the rate of spread of the decay.

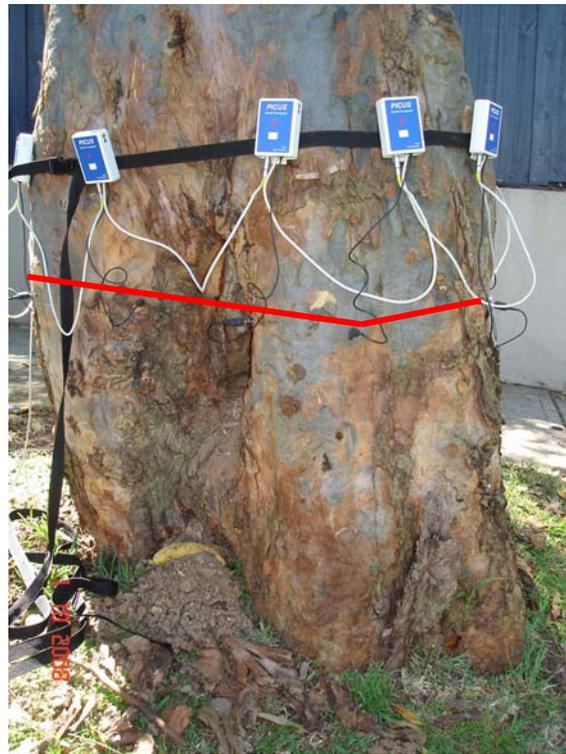
The subject tree has a large stem wound at the base on the western side and is showing evidence of bulging (Plate 3). The wound has been tested as decay located at the base of the tree could possibly cause the tree to fail at the base if large portions of the trunk are decayed.

Plate 3: Image shows the wound and bulging occurring at the base of the trunk. Red line is the approximate location of the test site.

The tree has symmetrical form and has normal canopy density for the species. The crown spread is eight (8) metres. The branch attachments within the canopy appear sound. There is minor dead wood within the canopy. Old pruning wounds show good occlusion indicating that the tree is in good health. There was no evidence of fruiting bodies, cracks or splits on the trunk. I could see no evidence of termites. There is a large wound present on the western side of the trunk, probably due to mechanical damage. Wound wood is developing around this wound and is causing the lower portion of the trunk to have a bulging appearance.
